**Experimental Investigation on the Influence of Surface Defects on
High-Speed Gear Performance**

Undergraduate Honors Thesis

The Ohio State University

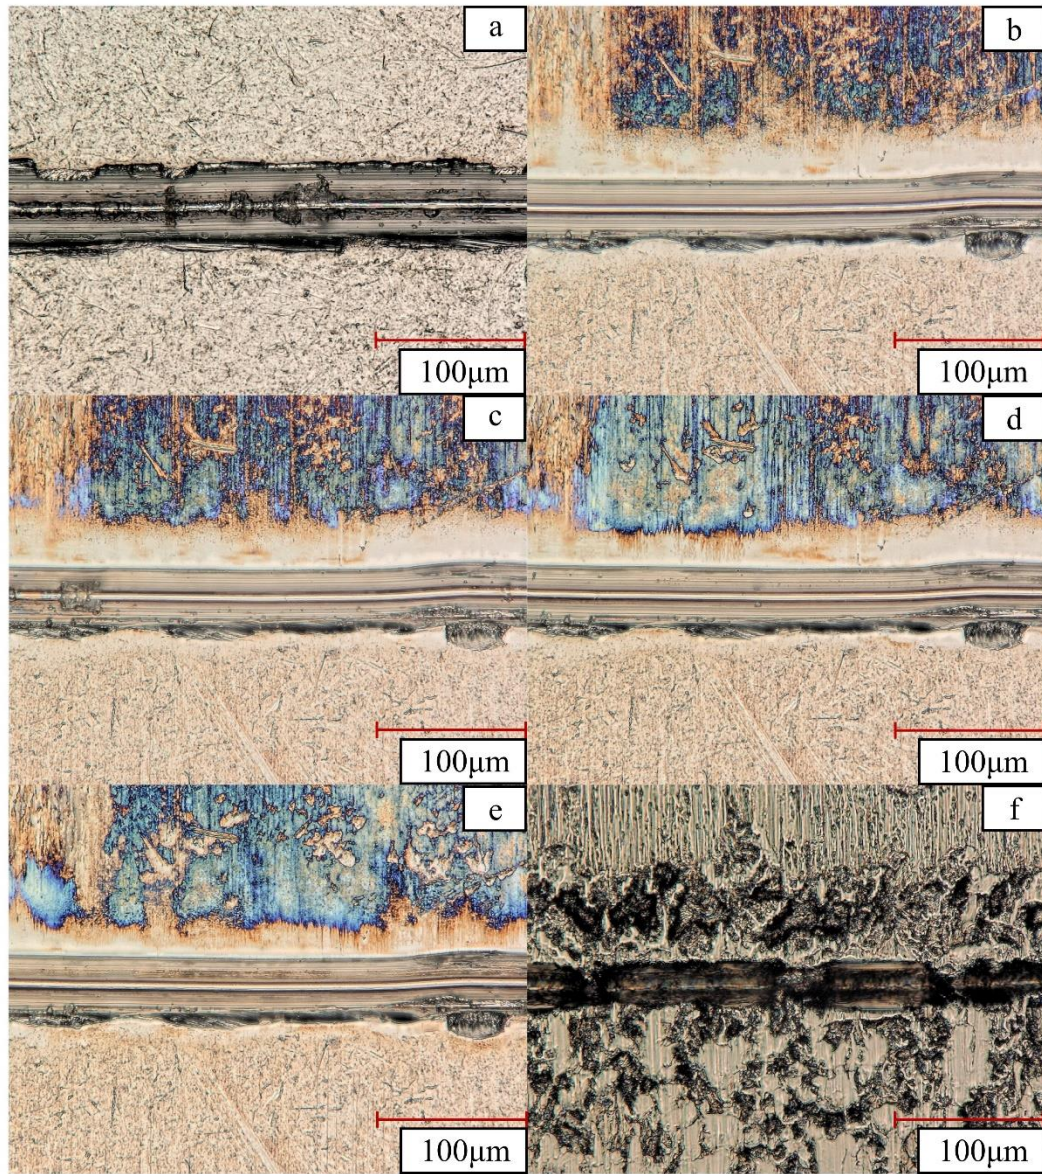
Figure 3.17: 1000X microscopic of the HPSTC scratch in site 4 (a) before the test, and after the stages of (b) run-in, (c) A1, (d) A2, (e) A3, and (f) A9.
